## PIC12F508/509 Rev. A Silicon/Data Sheet Errata

The PIC12F508/509 parts you have received conform functionally to the Device Data Sheet (DS41236C), except for the anomalies described below.

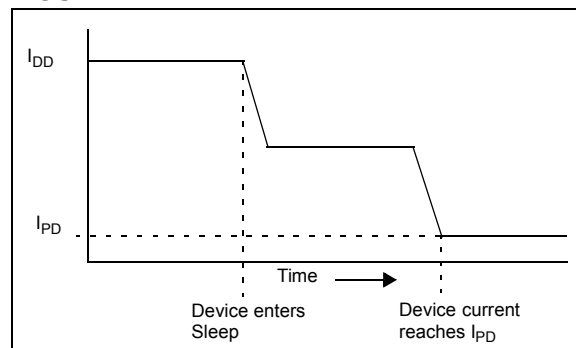
**FIGURE 1:**

On the PIC12F508/509 silicon, revisions earlier than A3, the power-down base current may remain higher than the specification for a short time when entering Sleep.

The following graph illustrates the device current upon entering Sleep:

The length of time between the device entering Sleep mode and the device current reaching  $I_{PD}$  increases as both temperature and voltage decrease.

This issue is fixed in Revisions A3 and later.
